## **Public Testimony: Willow Ridge Geologic and Hydrologic Risk Parameters**

### **Willow Ridge Proposed Development 4096 Cornwall St., West Linn, OR Tax Lot: 6300**

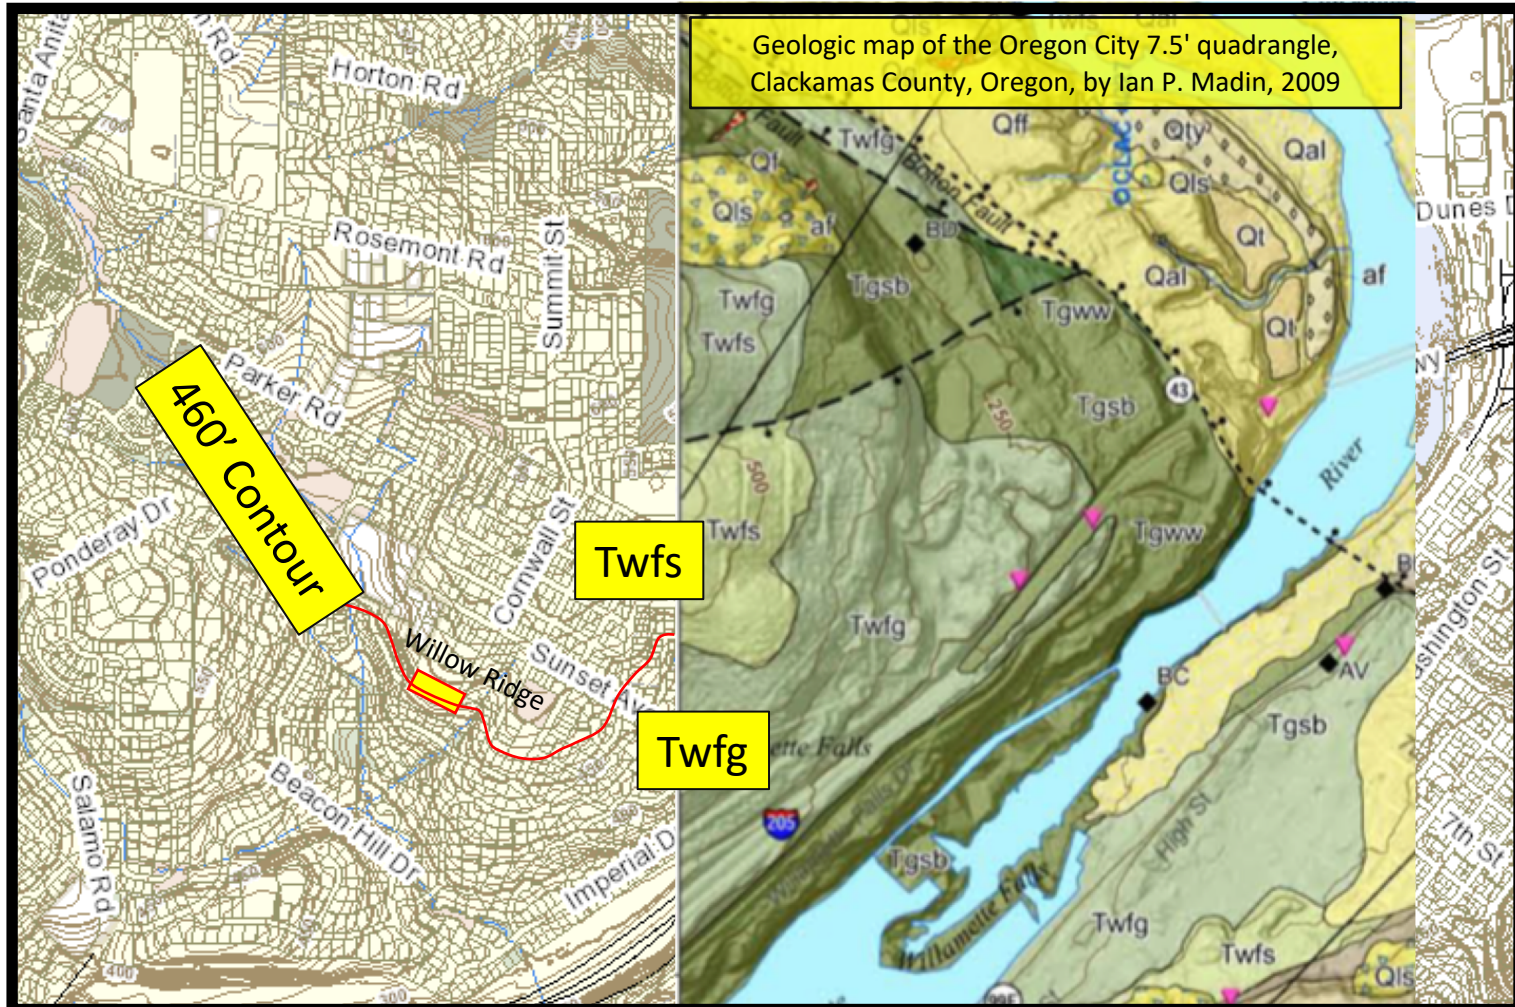
Exhibit 1

The Frenchman Springs member is divided into the upper Sandy Hollow Unit (Twfs) and the lower Gingko Unit (Twfg) (Exhibit 1a). The contact between this units occurs at 460' ASL on the western edge of the Oregon City Quadrangle geological map. The tabular nature of these units allows a reasonable interpretation that the contact will be at the same level 1,570 feet to the west of the geologic map in the Willow Ridge development (Exhibit 1).

Maps showing the extension of the contact between the Sandy Hollow and Gingko units of the Frenchman Springs member of the Wanapum Basalts

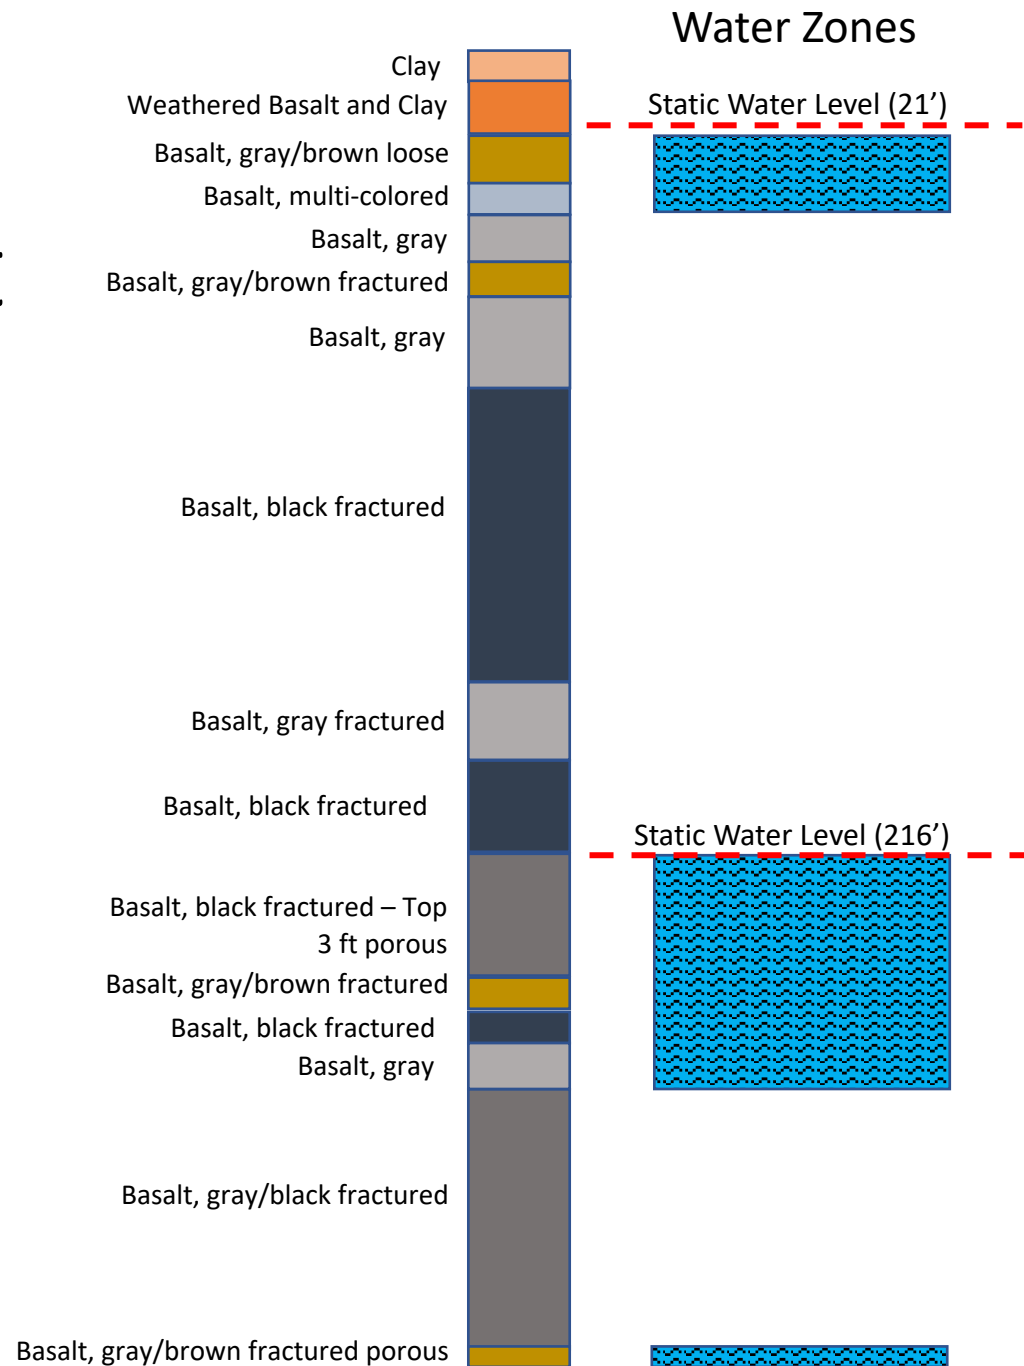
# Wellbore Profile: 4197 Reed Street

The base of the water-bearing zone is 462 feet ASL. This correspond closely with the projected geological contact between the upper and lower Frenchman Springs units. Below this contact gray basalts followed by gray/brown fractured basalts were encountered. The next water zone in the well was encountered between 216 – 280 feet ASL.

Perched water was encountered in this well with a floor at 46 feet below ground level or an elevation of 462 feet asl

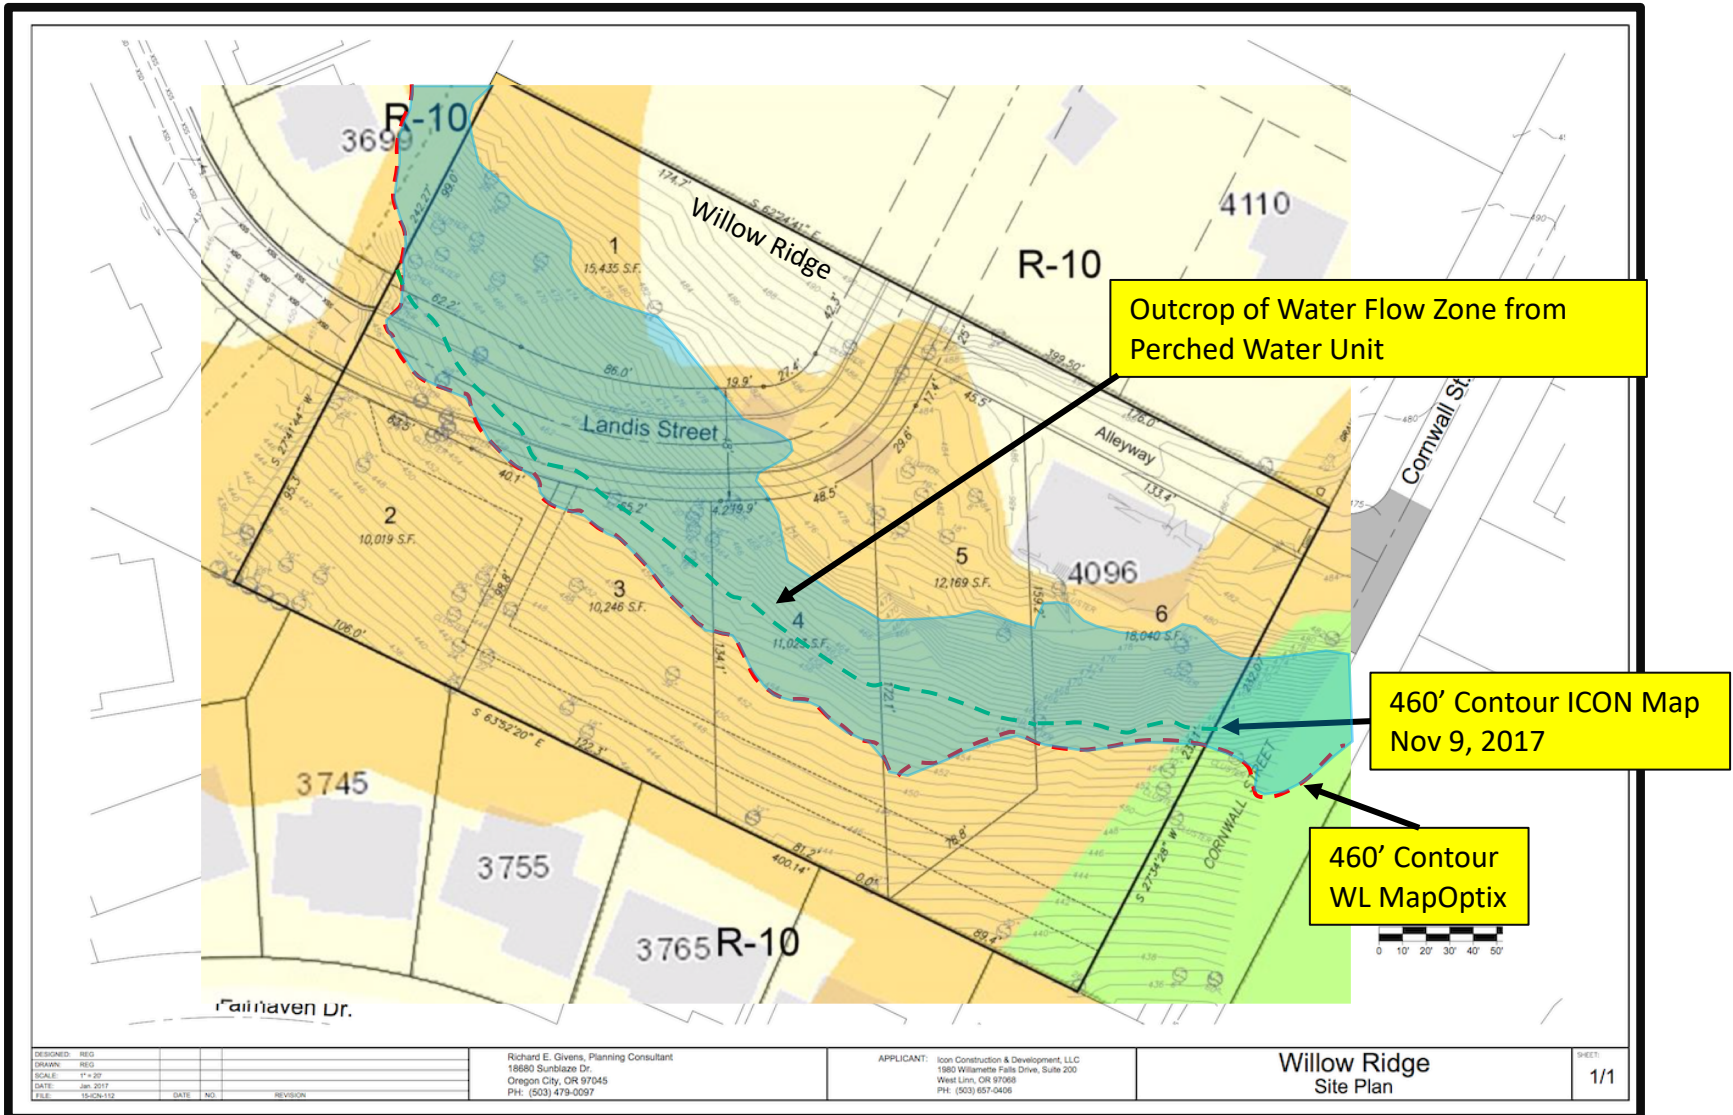
## Exhibit 6

The steep slopes of the Willow Ridge Development represent an area where the topography cuts through the Frenchman Springs basalts and exposes the perched water unit to the surface. The water zone cuts across the development area in a generally NW-SE line, following the topography between 460 – 480 feet asl (Exhibit 6).

The water zone map in Exhibit 6 was constructed using the MapOptix contours. The exhibit denotes differences between the MapOptix 460 foot contour and the ICON maps used in their original planning application.

# Estimated Water Flow Zone based on the Reed Street Well (Uses terrain contours from MapOptix)

Reasons for differences between the ICON map contours and the MapOptix terrain contours are unknown

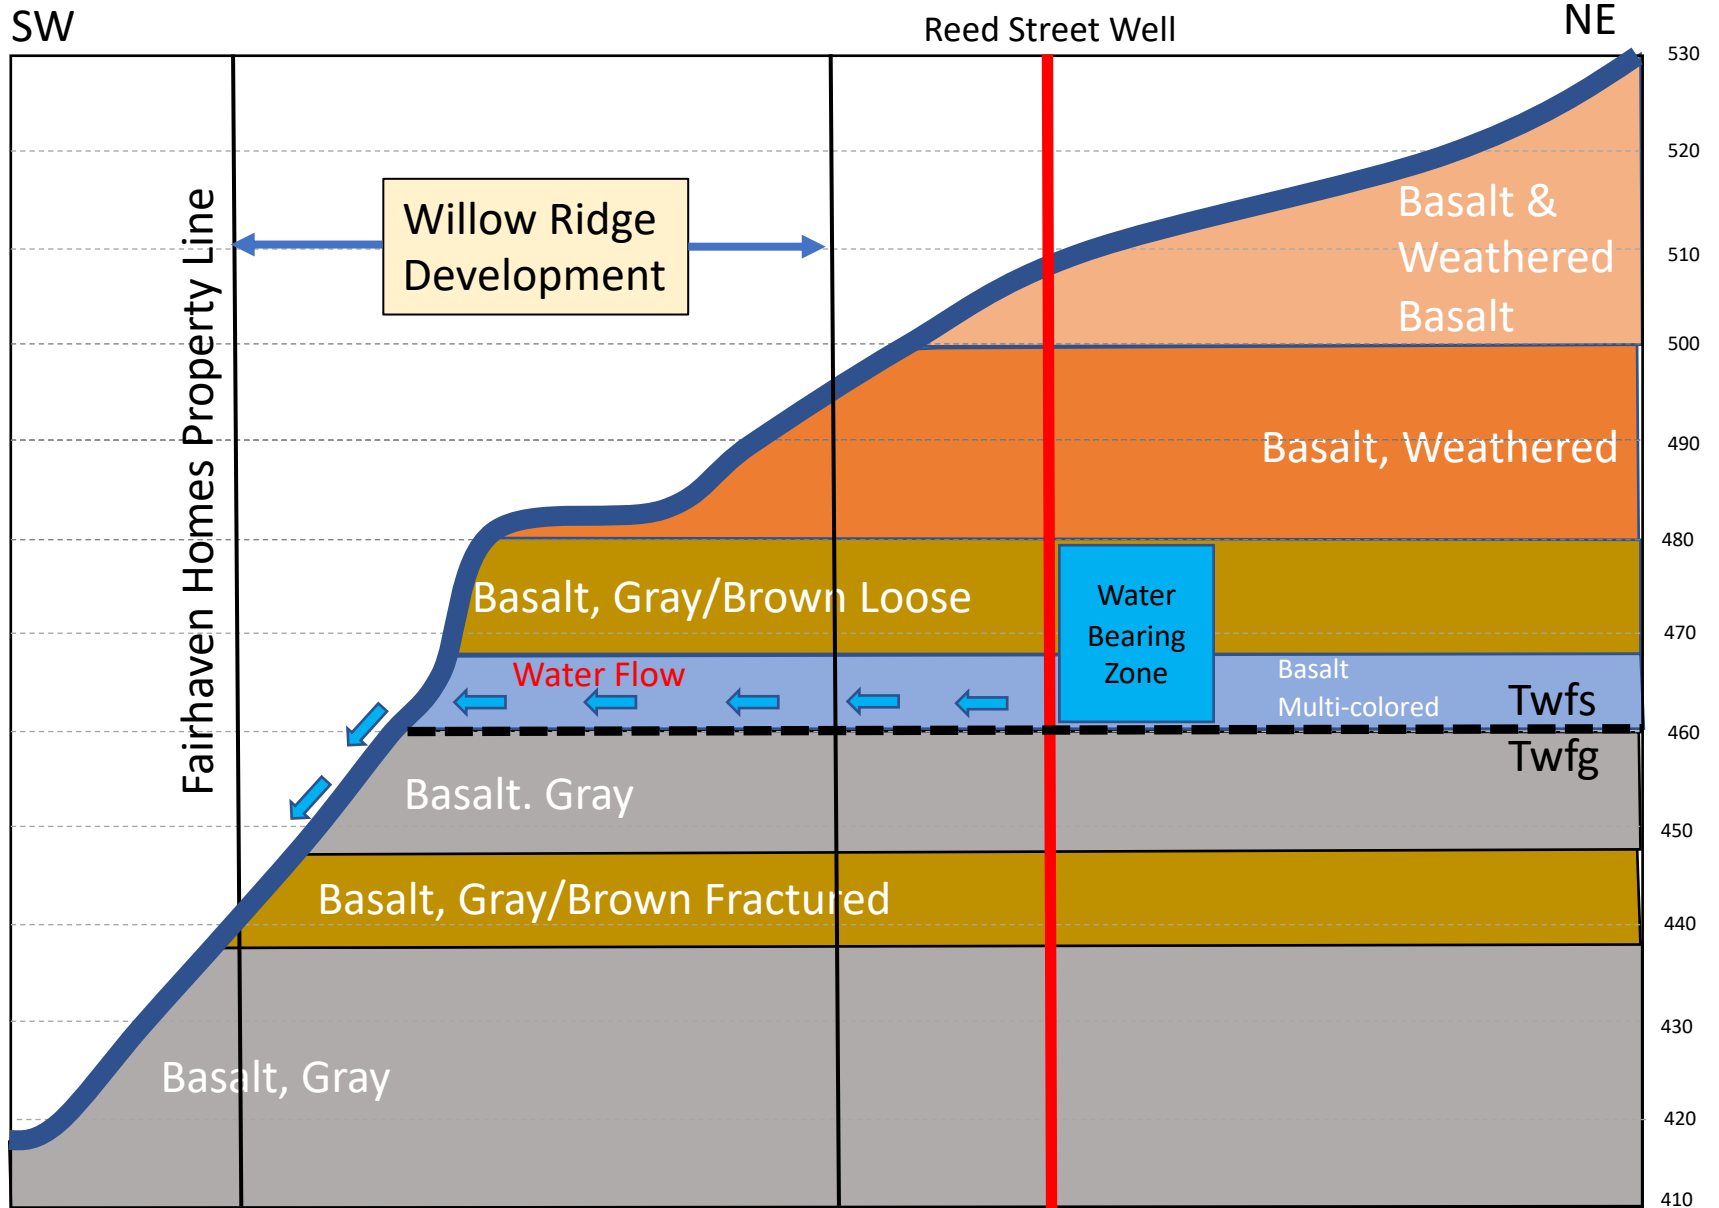
# Geologic Cross Section (Profile)

A cross sectional representation of the local geology and the perched water zone is shown in Exhibits 7 & 7a. The diagram shows the natural water flow from the subsurface to the surface

along the Willow Ridge slope. The zone of flow corresponds to the noted presence of live springs and water loving Willow trees that occur naturally along the length of the ridge.

The dynamics of this natural water flow system are such that water enters the system via precipitation on the ground surfaces above the 460 foot contour. The water migrates vertically into the soils until it reaches the top of the gray basalt layer at about 460 feet ASL. This layer forms a permeability barrier and the water accumulates as a perched aquifer. The free surface along the Willow Ridge slope provides an exit point for the water and allows the aquifer to drain (Exhibit 7).

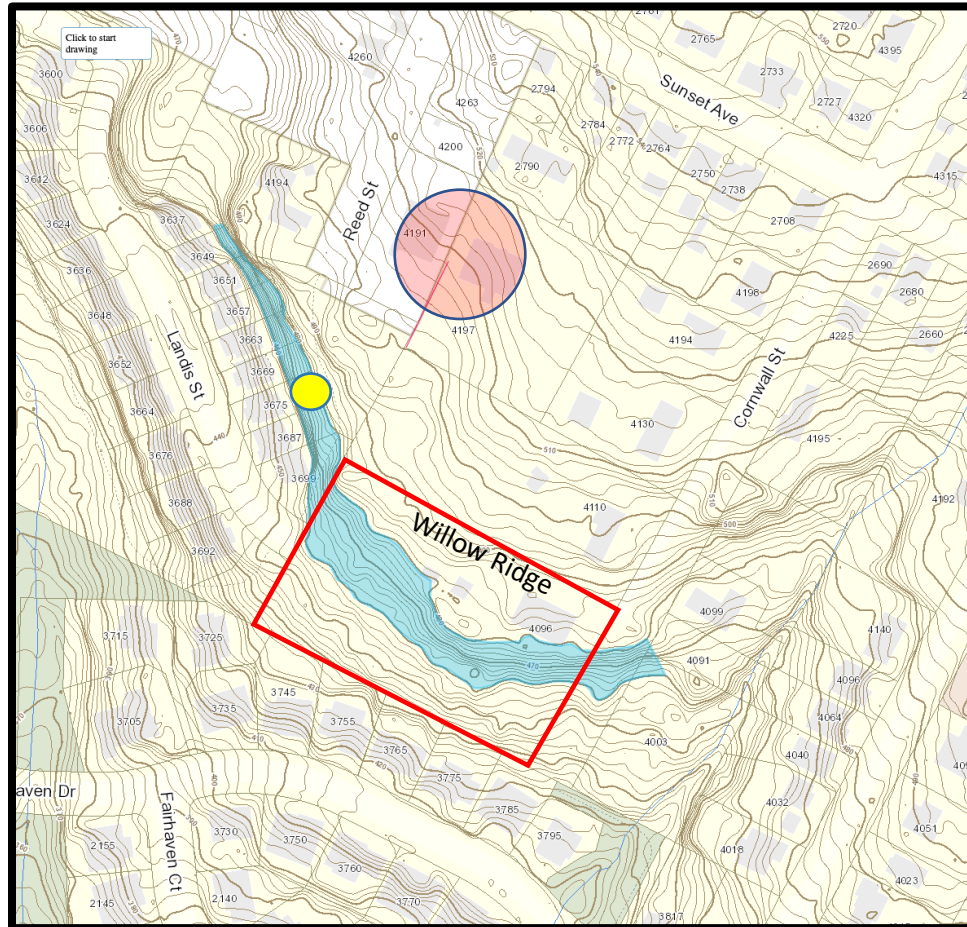
## Public Testimony Dec. 2017:

Public testimony in 2017 by Chelsea Diaz demonstrated a clear connection between upslope changes in drainage cause by construction and the subsequent increased water flow from the same geological formations that occupy the Willow Ridge Development slopes. The location of this incident was immediately to the NW of the Willow Ridge plot in the Stonegate community. The perched water table outcrops behind the Diaz home, and flooding problems from that zone coincided with upslope construction (Exhibit 8).

"After two homes behind and above us began construction located at 4191 Reed Street and 4197 Reed Street, I noticed water streaming between the boulders in my 25 foot retaining wall into my back yard. I then began an lengthy process of trying to find where the water was coming from. After a landscape developer investigated the issue, he determined that a new spring had formed in the upper tier of my back yard."

This demonstrates the clear connection between construction and changes in drainage above the slope and increased water flow through the "water flow zone" marked in blue.

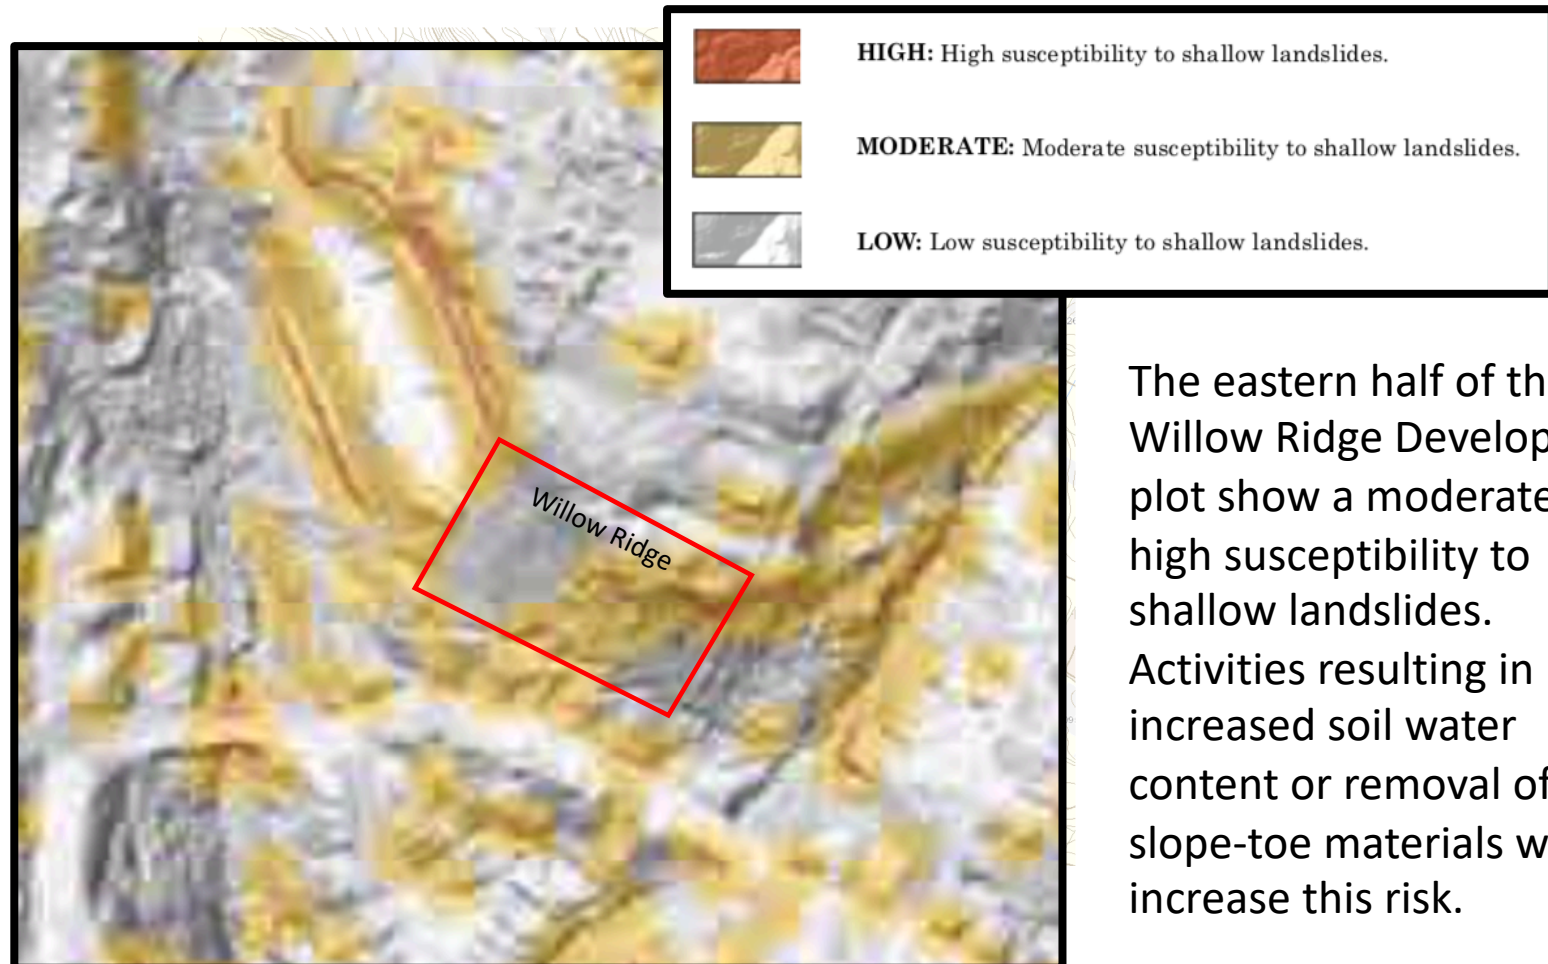
# Shallow Landslide Risk – Oregon State Department of Geology and Mineral Industries

The eastern half of the Willow Ridge Development plot show a moderate to high susceptibility to shallow landslides. Activities resulting in increased soil water content or removal of slope-toe materials will increase this risk.

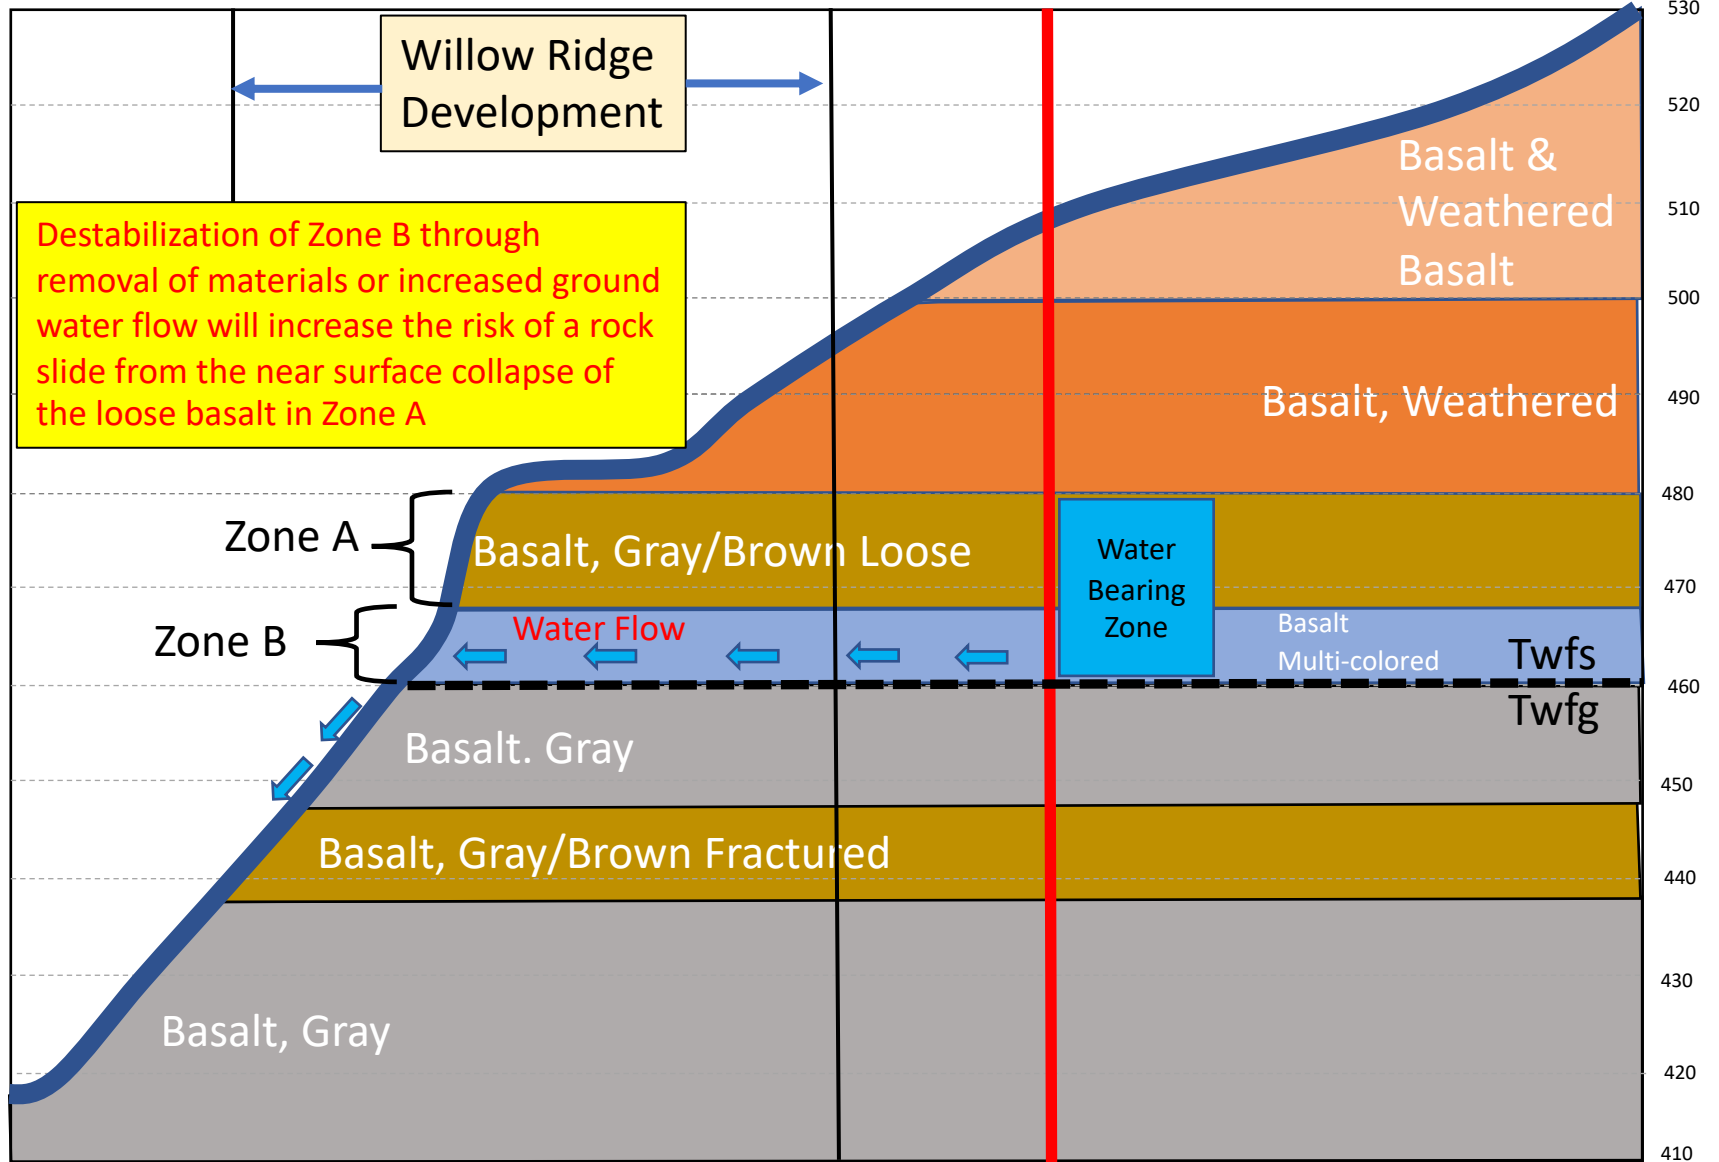
# Rock Fall Risk

The two factors to evaluate for this risk are: planned removal of material during construction, or increased water flow (surface or subsurface) at the base of the slope. The current understanding of the geology is that water is currently exiting the toe of the steepest slope in the form of springs. Any changes above this seep zone that result in increased ground water will cause increased water flow from the existing seeps or the formation of new seeps at the toe of

the slope. This increased flow could destabilize the slope toe and result in increased risk of landslide (Exhibit 10).

Based on the geology of the Reed Street Well the steepest portions of the existing slope are composed of loose, gray/brown basalt. The next zone of gray/brown basalt approximately 20 feet deeper is described as fractured. Loose or fractured basalt indicates a degree of disaggregation in the rock unit. Removal of structural support at the base of this unit on the slope could result in near surface collapse of the overlying unit and disaggregation of the mass into a shallow rockslide.
